SOUTH OF IRELAND TREE SURVEYS

TREE SURVEY

South of Ireland Tree Surveys have been instructed by O'Flynn Construction LTD. to conduct a tree survey at Maglin, Cork, prior to the development of the site.

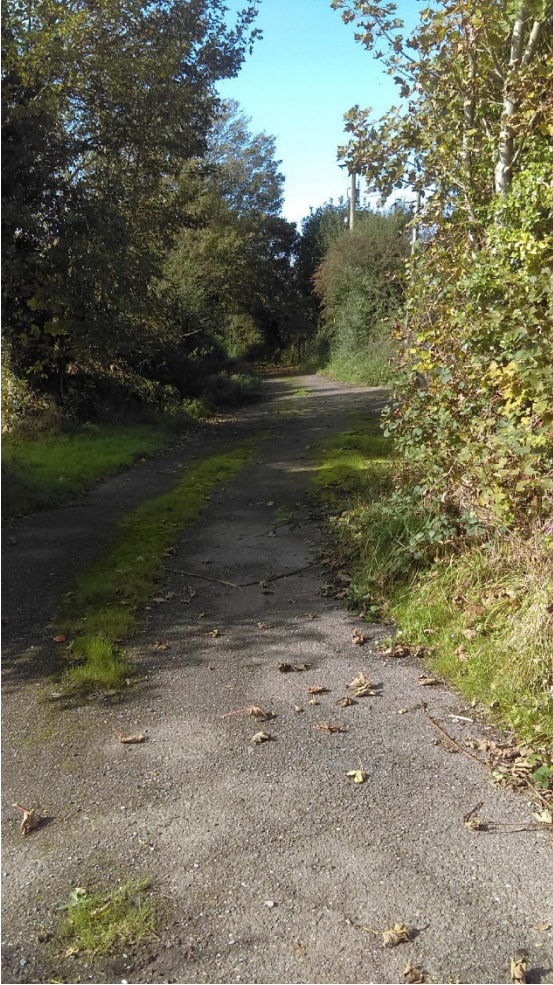
1. Avenue approaching Maglin House farm buildings.

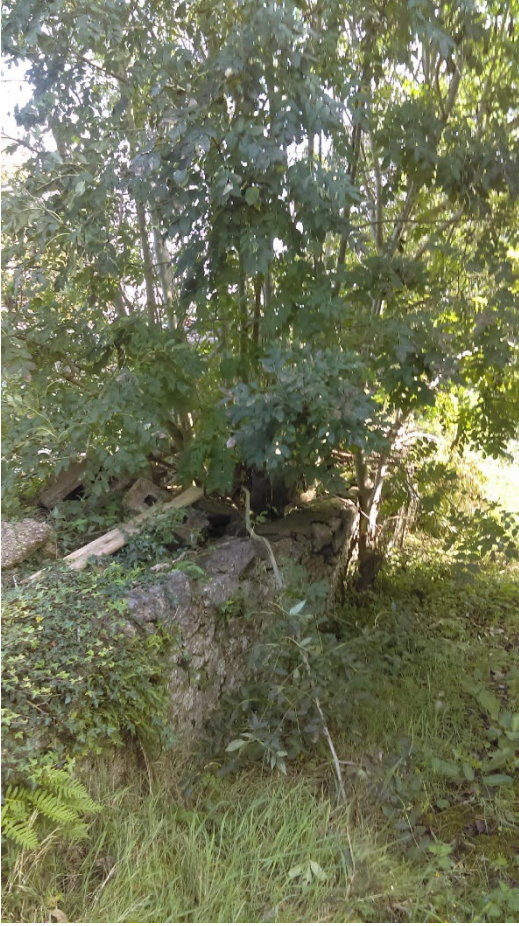
2. Scrub Ash adjacent to existing old dwelling.

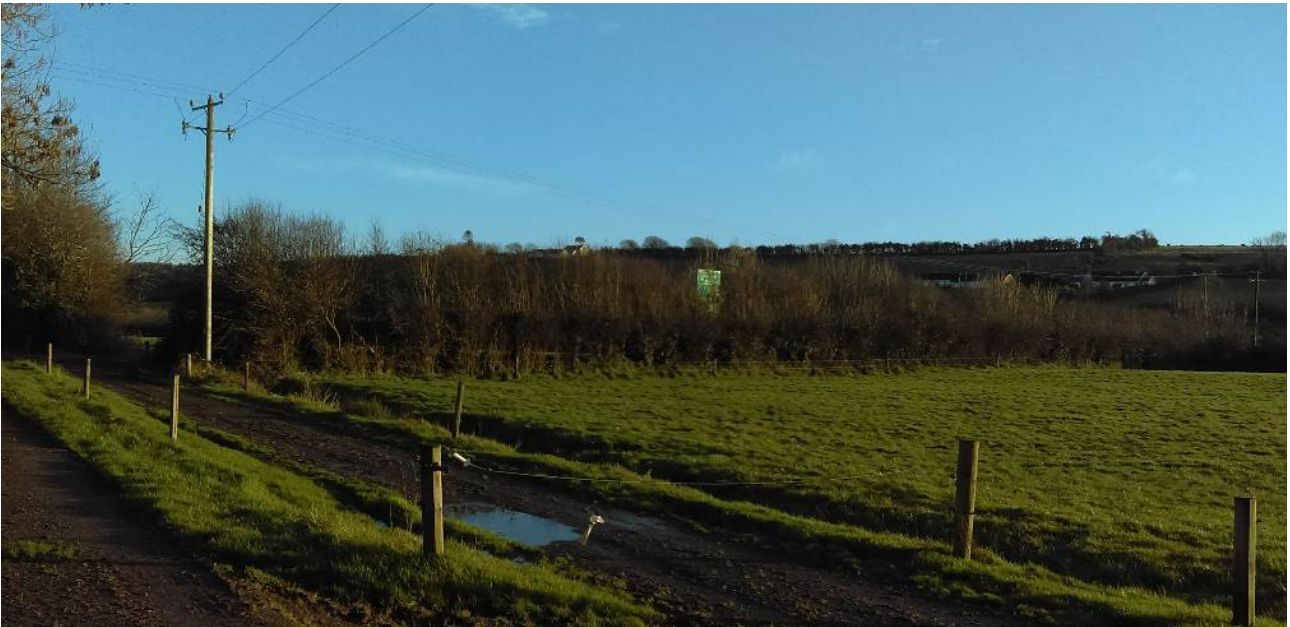
4. View of internal western hedgerow.

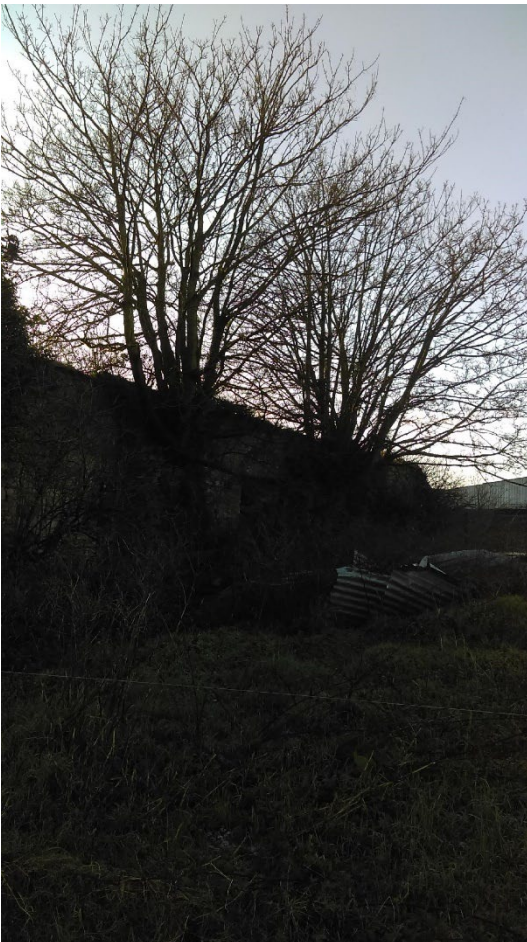
6. View of trees numbered (0729-0736).

0735	Sycamore	9m	3m N 2m S 3m E 3m W	400mm 4.8m	3m E	M	40+	Abuts wall of old building No decay visible Good	Nil	B
0736	Sycamore	16m	4m N 4m S 4m E 4m W	800mm 9.6m	3m E	M	40+	Abuts old stone wall Good	Nil	B

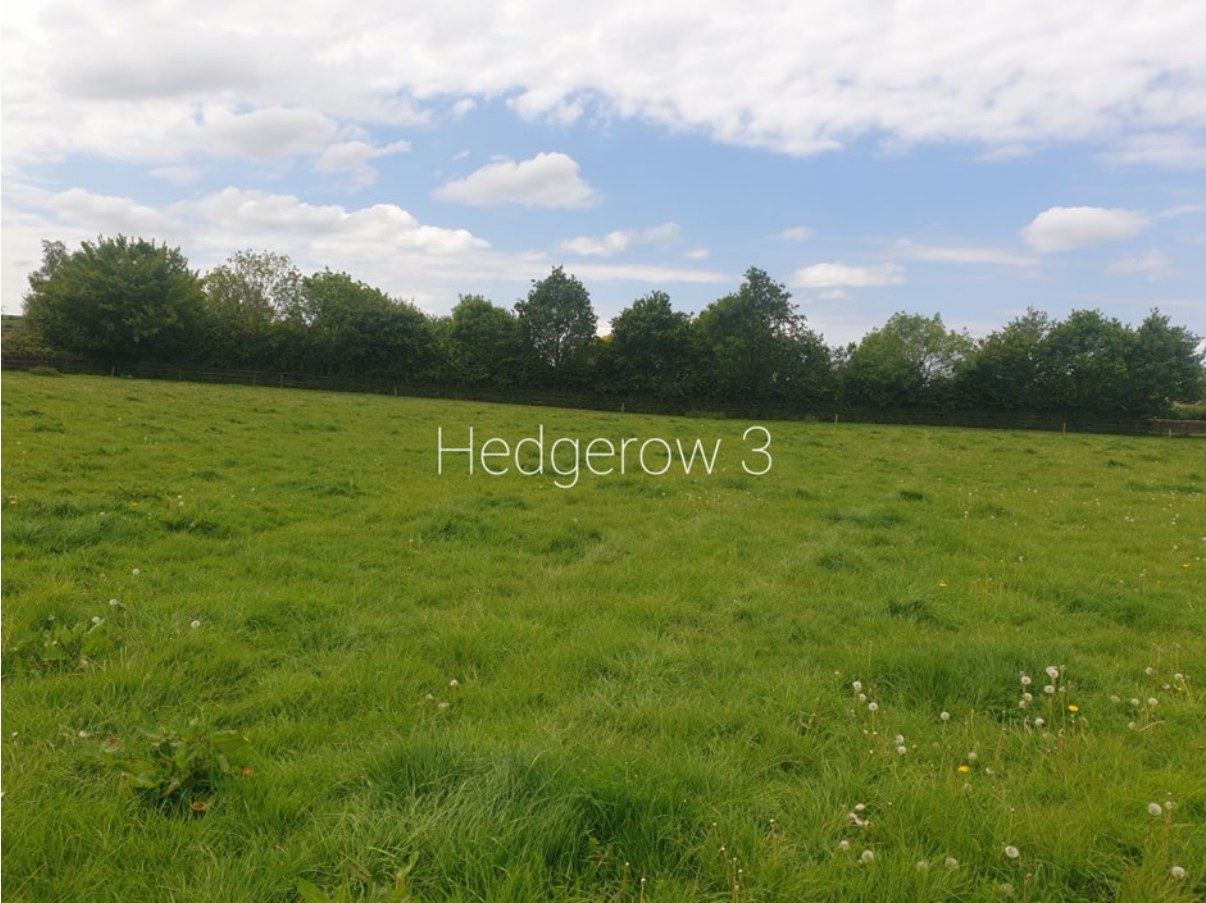
Hedgerow 3

(H3). A mixture of Elder, Hazel, Sycamore, Ash, Field Maple, Oak, Sindle, Birch and Wild Privet (dense).

8m deep, 10m height, condition excellent.

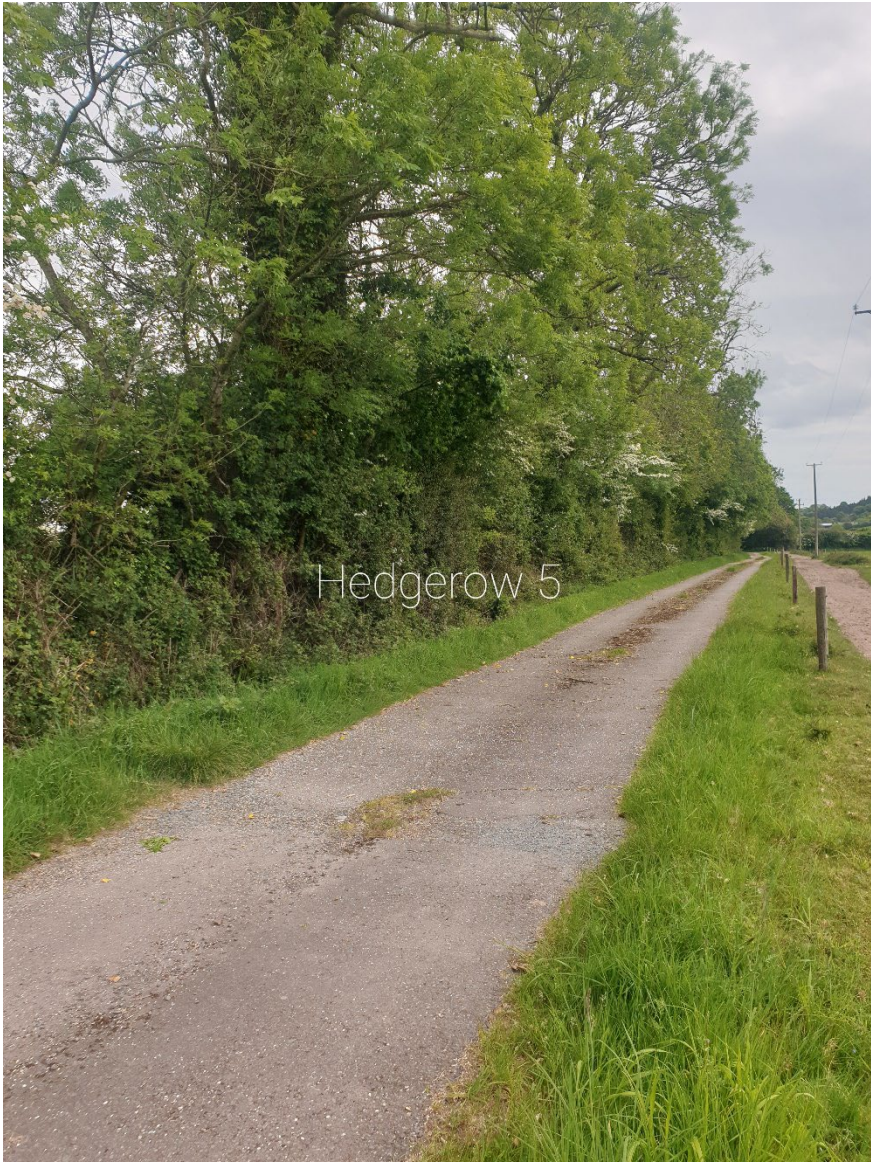
Hedgerow 5

Paddock 2 (H5). Mature Whitethorn, Young Elm, Crabapple and Young Ash.

4m deep, 6m height Av. Condition good.

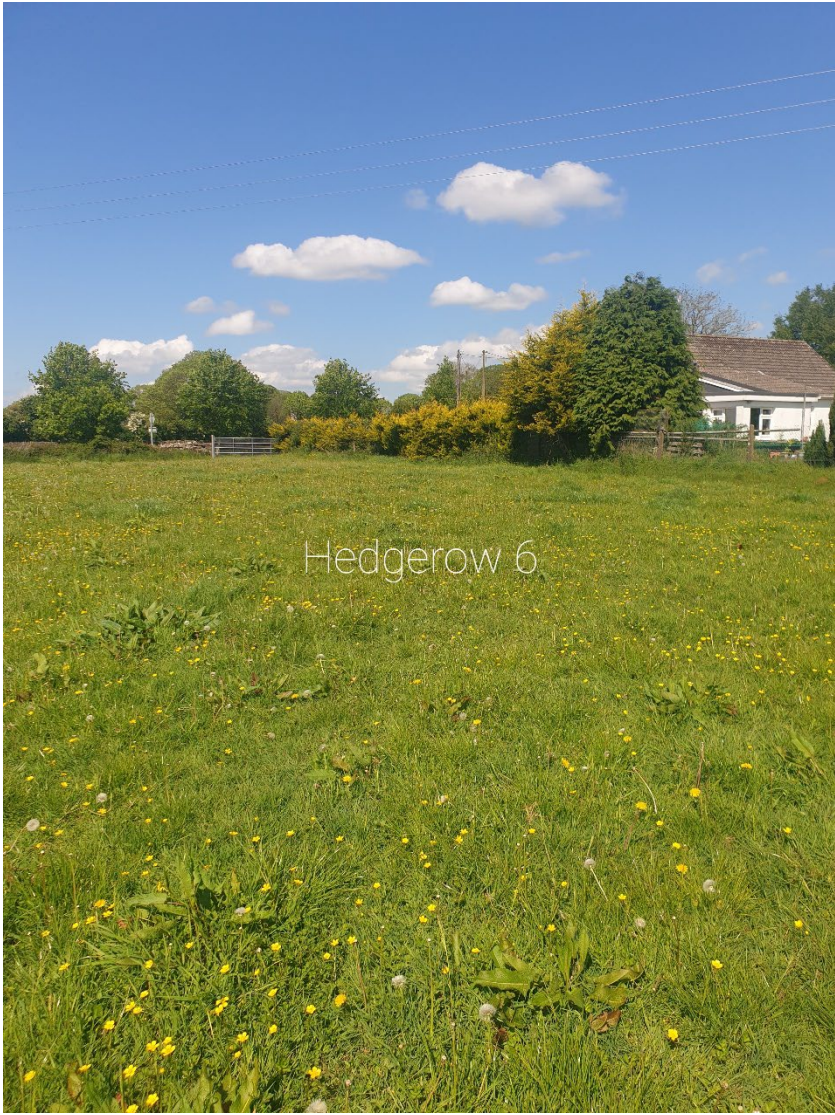
Hedgerow 6

(H6). No hedgerow at this position.

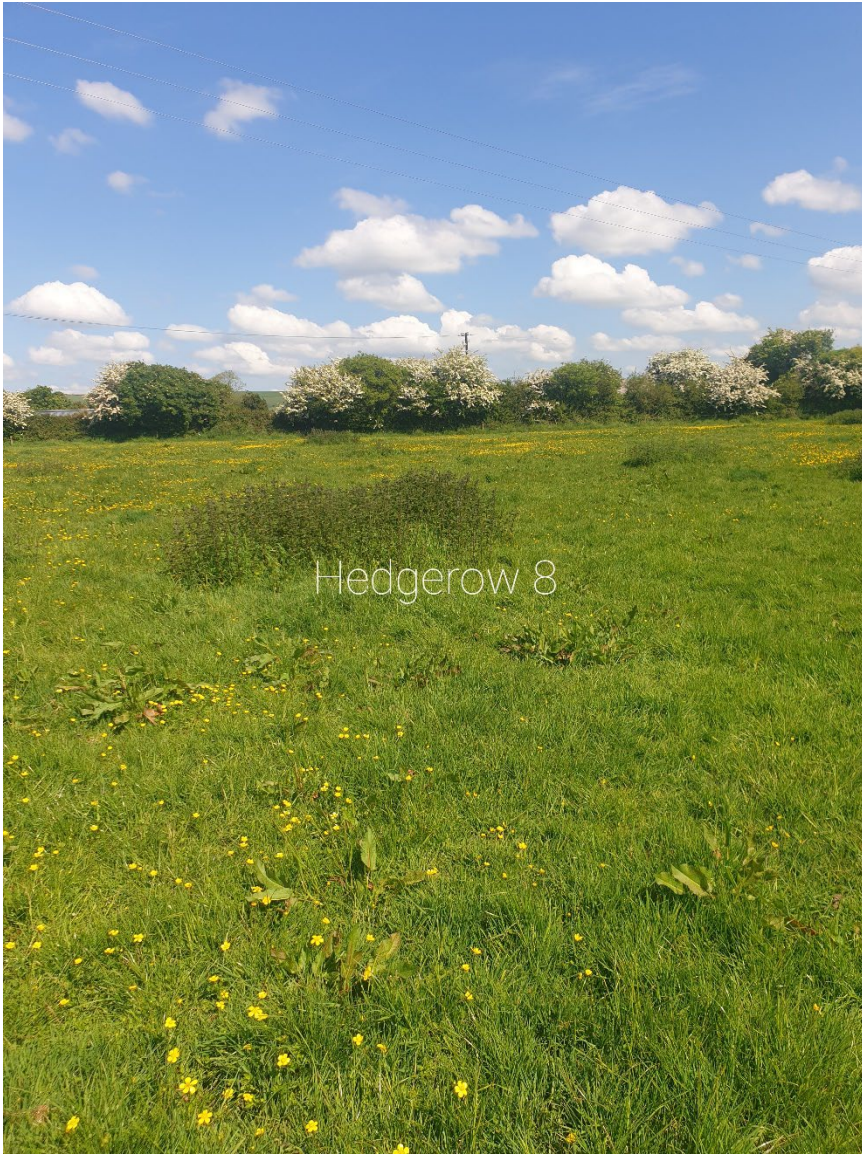
Hedgerow 8

(H8). Elder, Mature Whitethorn.

3m deep, 4m height, condition good.

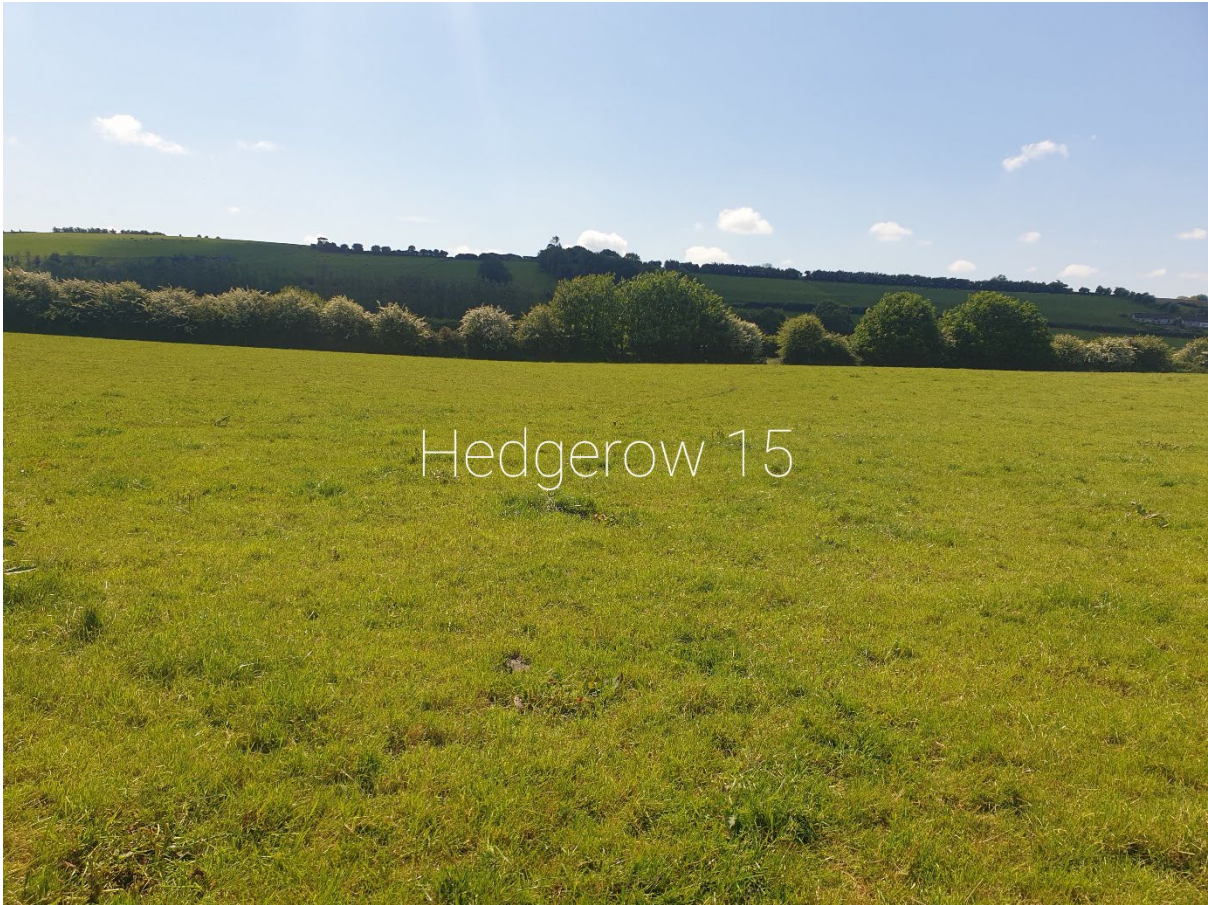
Hedgerow 15

(H15). Predomenently Mature Whitethorn.

3m deep, 3m height, condition good.

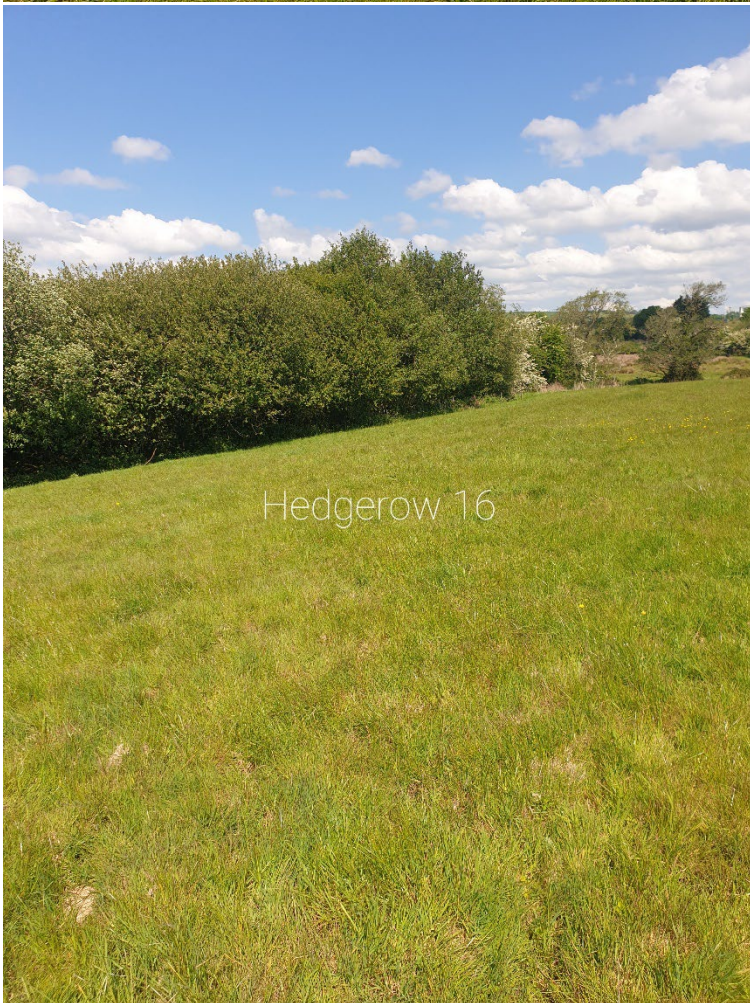
Hedgerow 16

(H16). Predomenently Scrub Willow, lesser amounts of Alder and Whitethorn.

6m deep, 5-7m height, condition good.

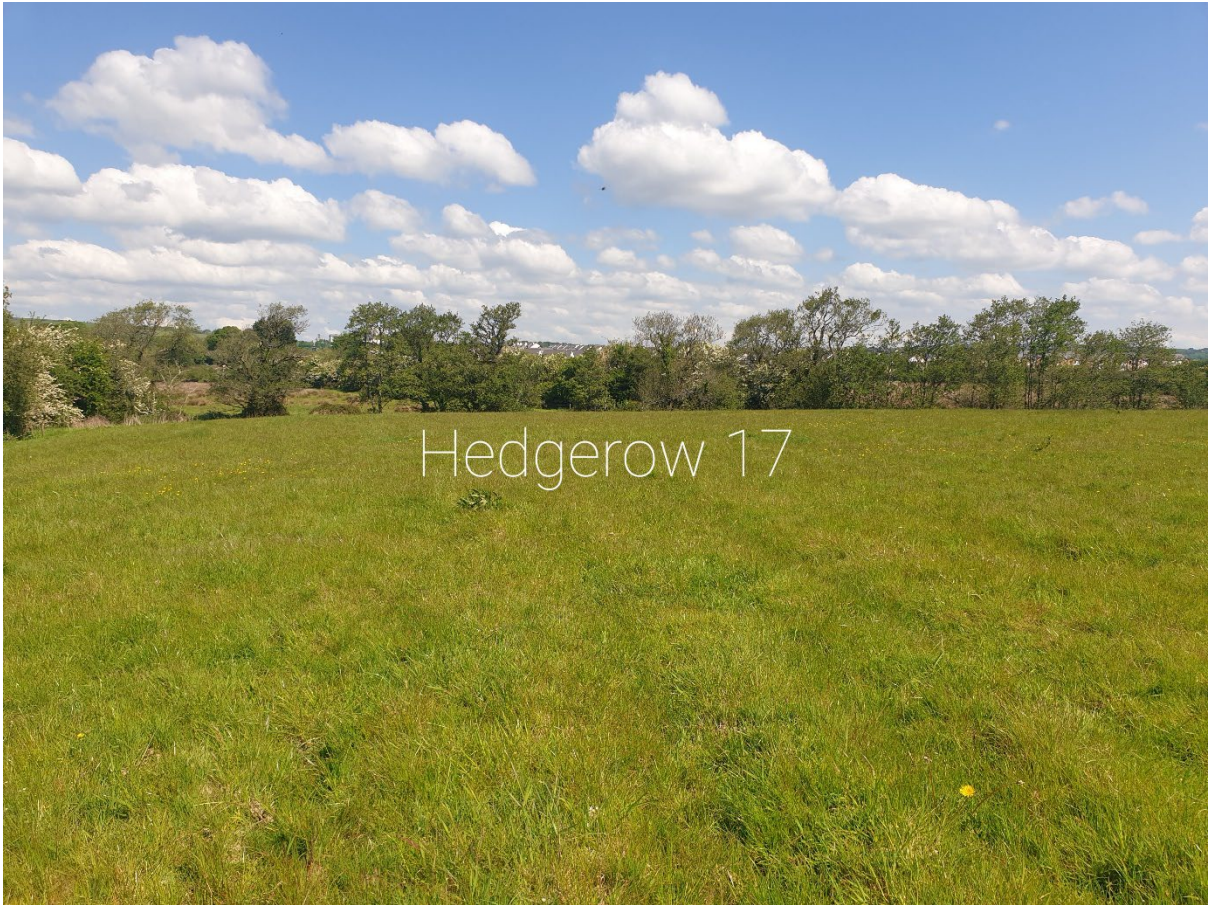
Hedgerow 17

(H17). Predominently Alder at the upper edge of the stream. Willow in the corner pinchpoint approximately 6 mature trees in number.

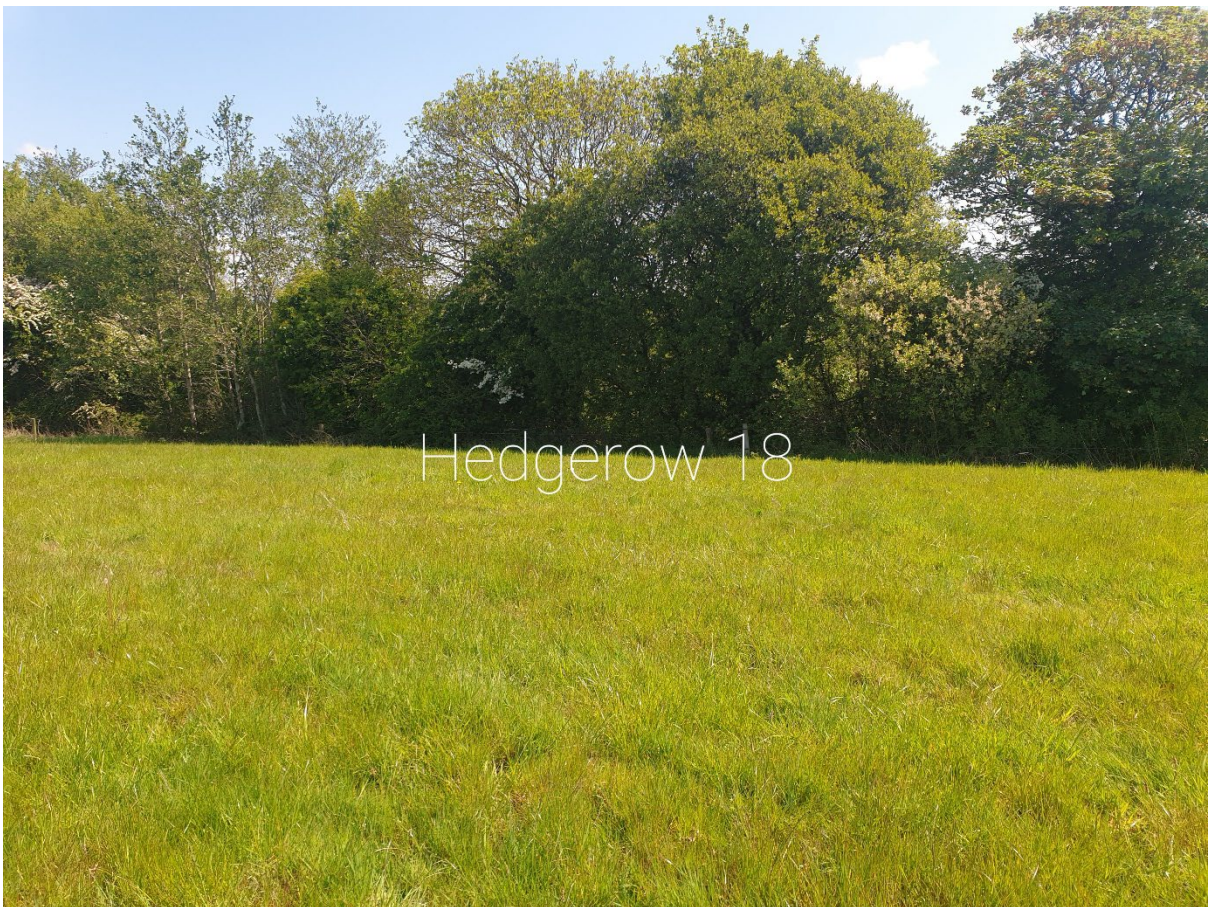
Hedgerow 18

(H18). Predomenently Scrub Willow, lesser amounts of Alder, Young Sycamore and Whitethorn. Briar also present on this hedgerow.

6m deep, 7-8m height, condition good.

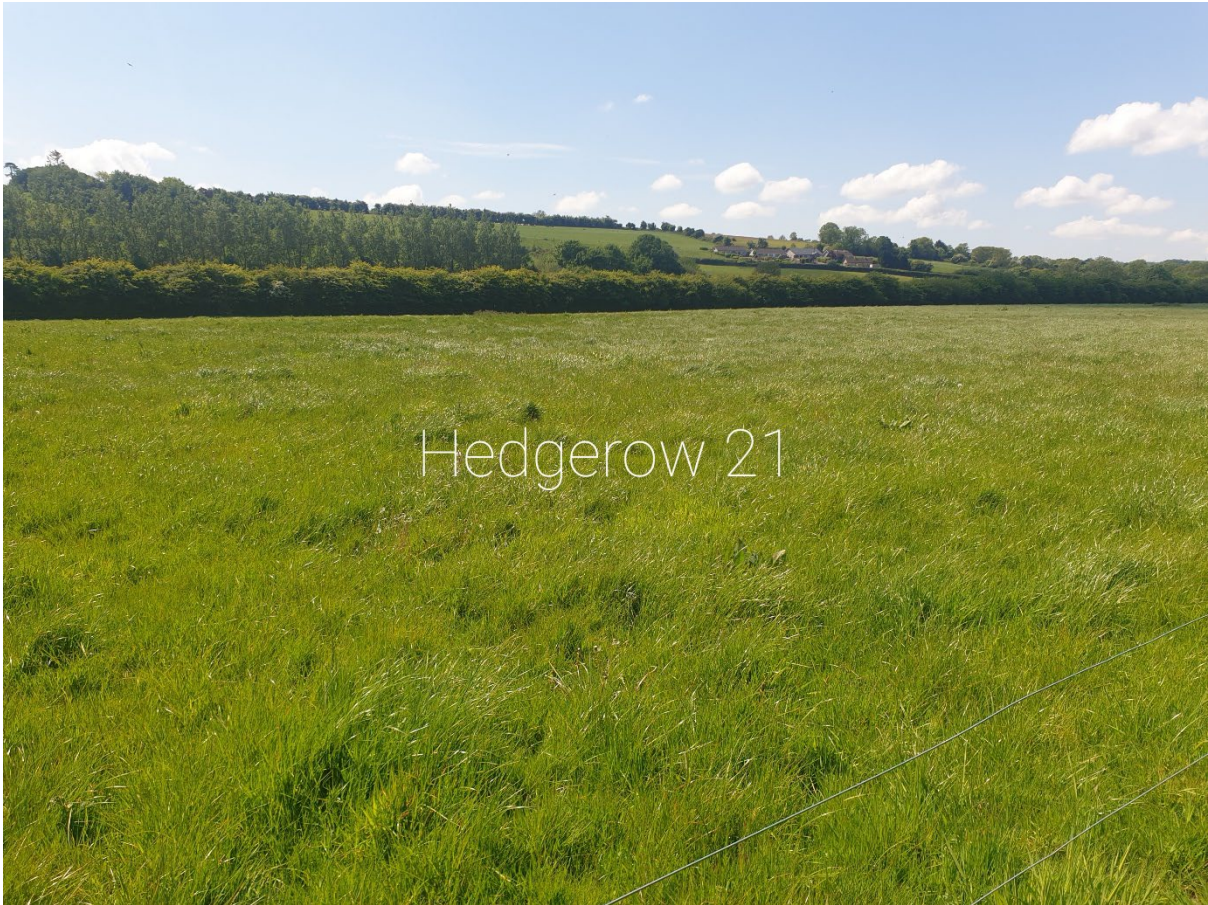
Hedgerow 21

(H21). Predomenently Whitethorn.

4m deep, 4m height, condition good.

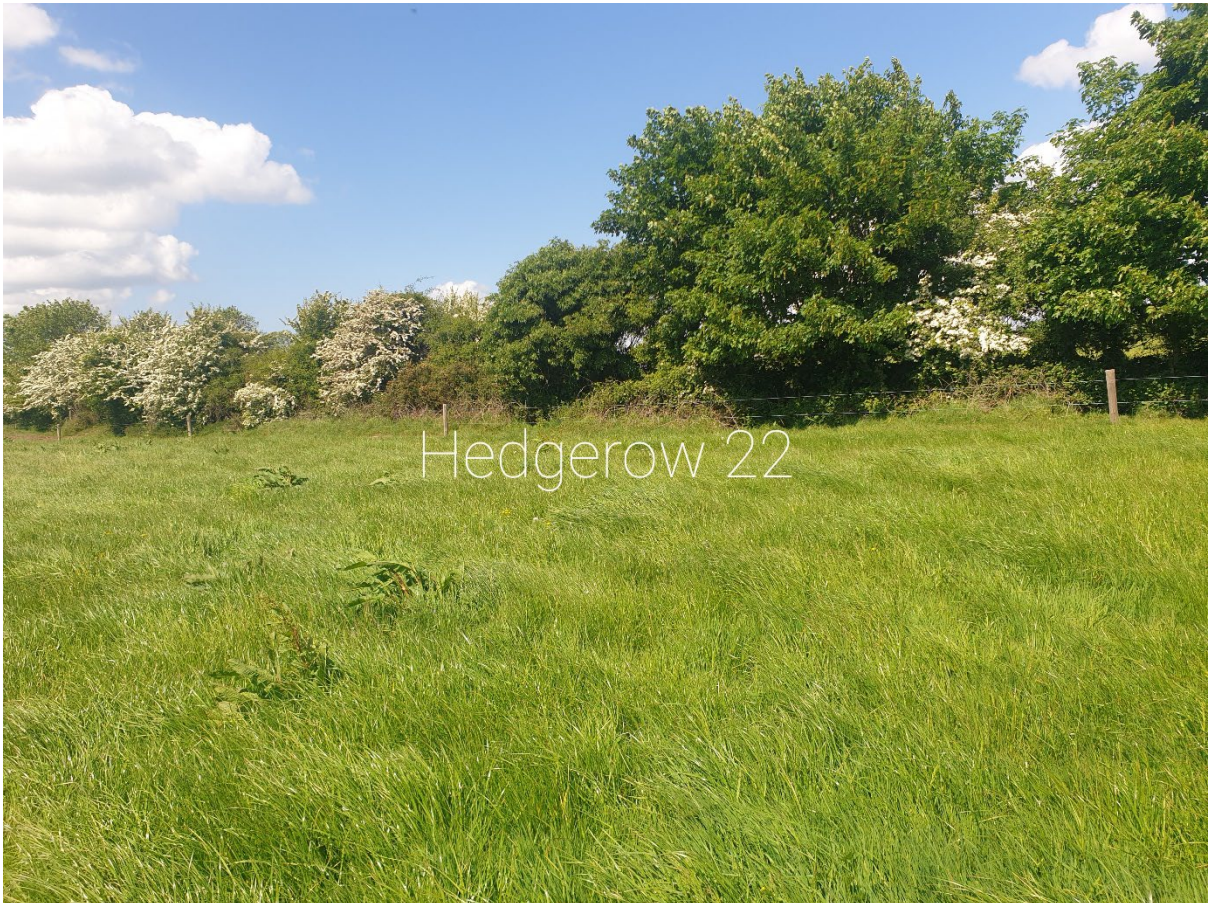
Hedgerow 22

(H22). Small amounts of Whitethorn, dead Elm and Mature Sycamore.

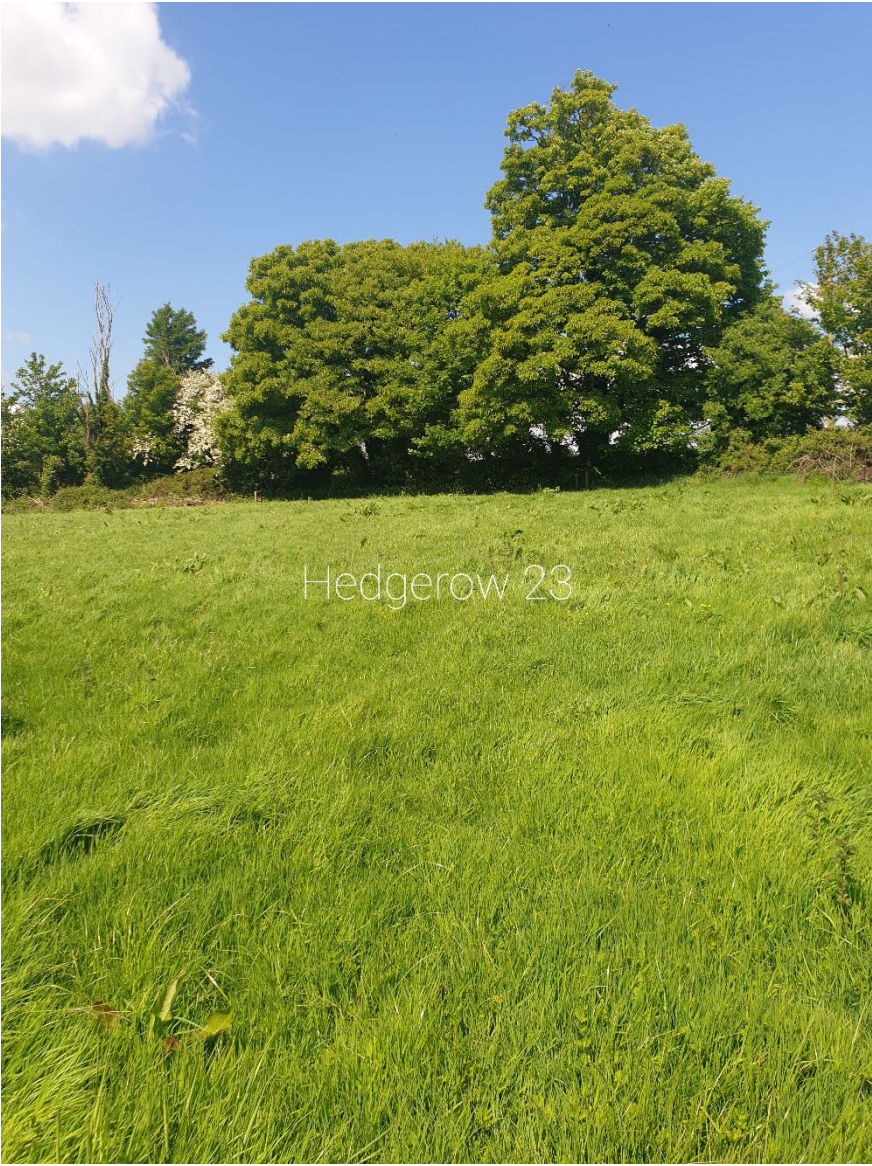
Hedgerow 23

(H23). Elder and Whitethorn. Dead Elm with Mature Sycamore. (Sparse hedgerow)

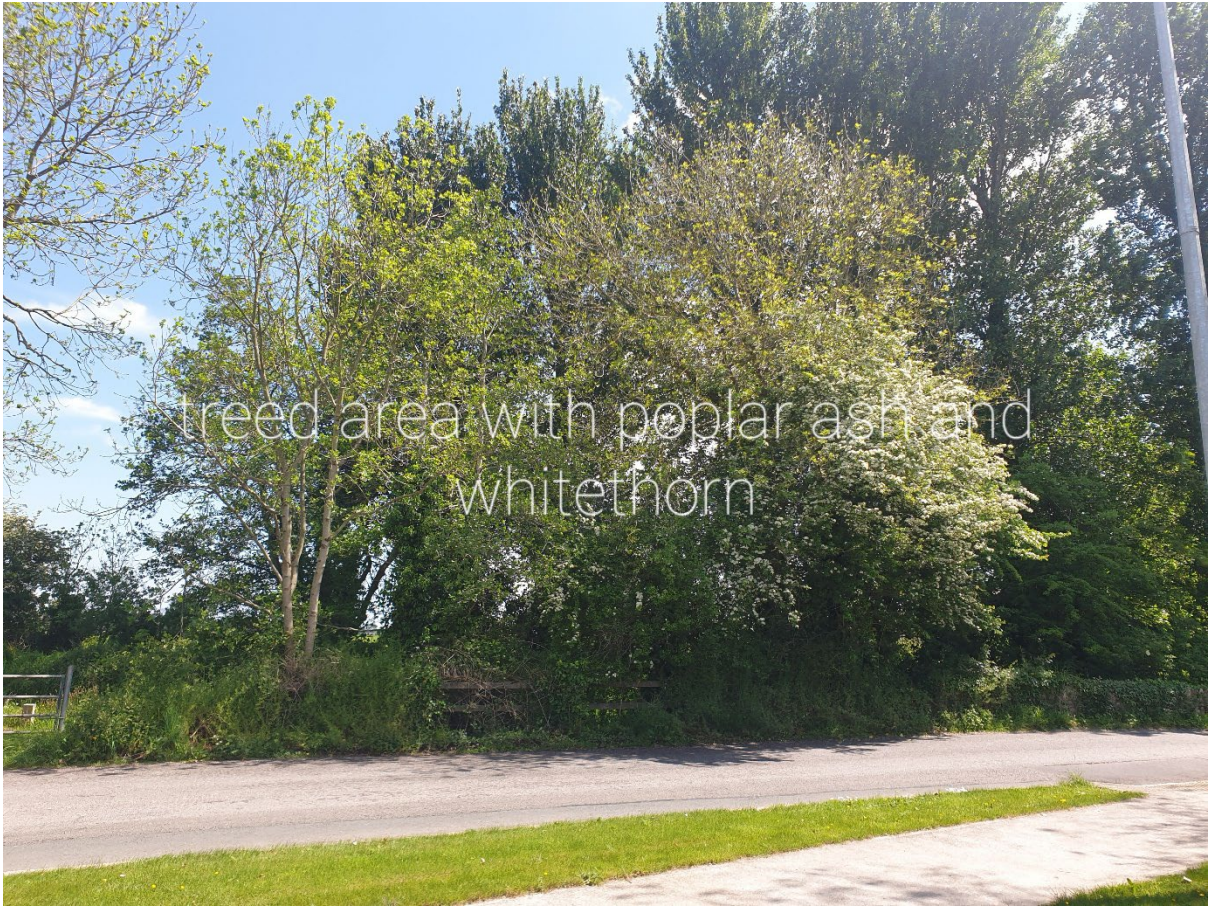
treed area with poplar ash and
whitethorn
