**For: O' Flynn Construction**

Residential Development, Maglin,  
Ballincollig, Cork

Quality Audit Report  
**September 2025**

**MHL & Associates Ltd.**  
**Consulting Engineers**

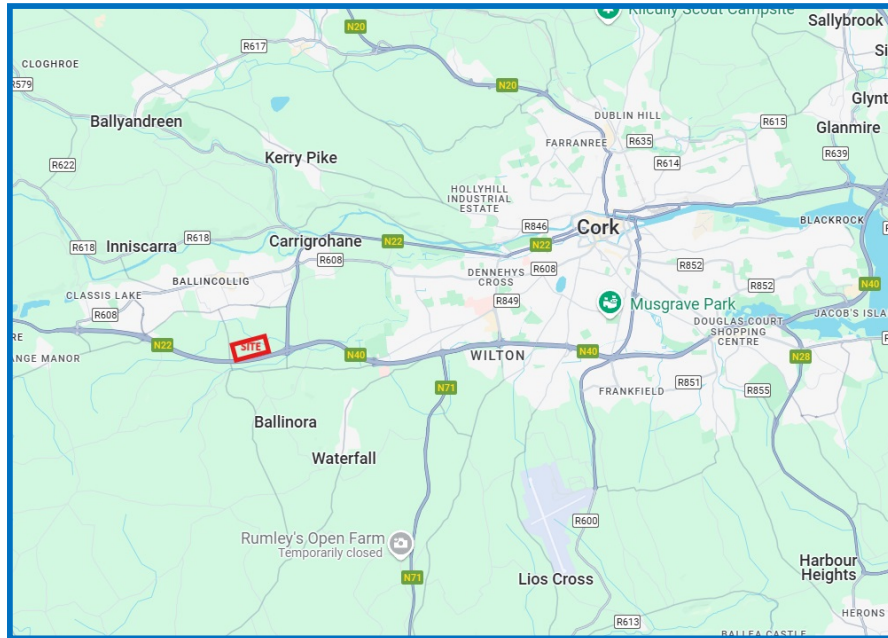
**Figure 2.1 Site Location in relation to Cork Metropolitan Area**

The location of the application site within the Cork Metropolitan Area is highlighted in **Figure 2.1** below. The lands are zoned ZO-02 New Residential Neighbourhoods in the current Cork City Development Plan 2022-2028.

The lands are bounded to the south by the N22 National Primary Road with existing local access to the Maglin Road, which is a local link road running north south between the Curraheen Road to the south and Castle Road to the north. To the north east the development will be accessed via the existing Heathfield Housing Estate. The overall Maglin lands form part of an SDZ (Special Development Zone) which the Cork Metropolitan Area Transport Strategy (CMATS) 2040 proposes to serve by means of a high capacity/frequency public transport route including bus lanes, cycle lanes and footpaths (BG-U-05). This link road has already been partially constructed as part of the aforementioned Heathfield Estate.

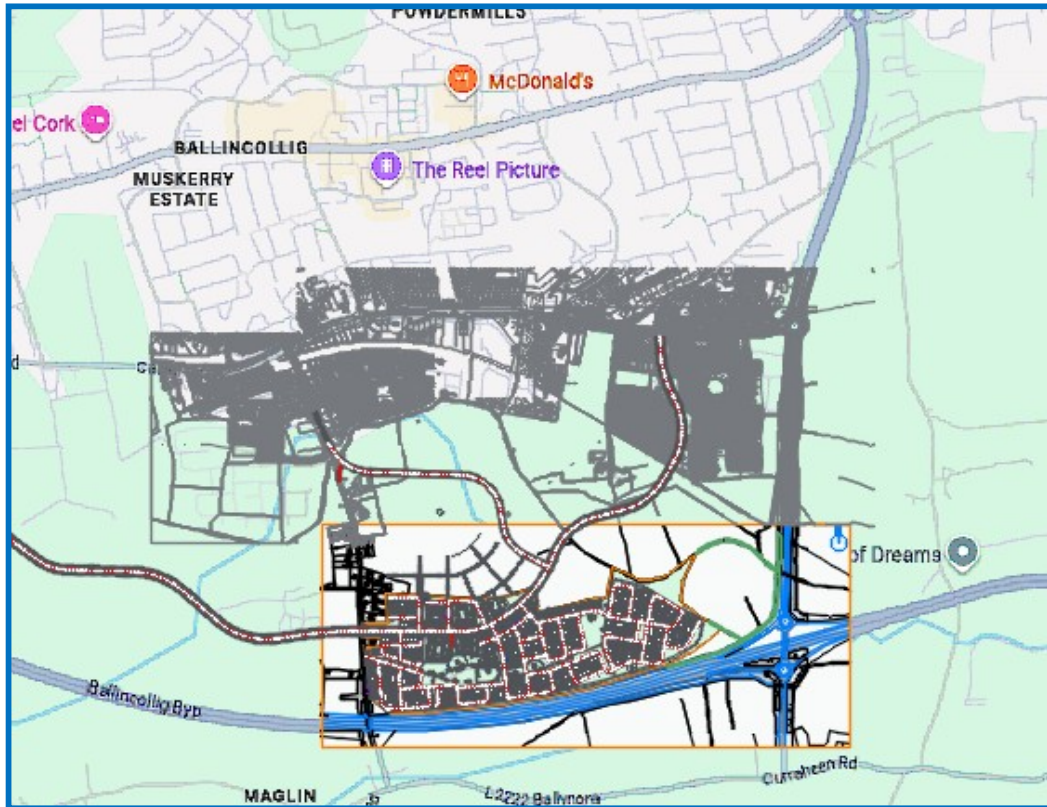
**Figure 2.2 Site Location within context of Ballincollig**

Figure 2.2 overleaf highlights the proximity of the site to Ballincollig Town and its educational, sport and recreational facilities. It shows that the majority of the town's amenities are within a 2-3km distance from the site. The provision of new pedestrian and public transport facilities in the vicinity of the site along with the presence of existing will help to ensure that the uptake of sustainable travel modes for the development can be realised.

The figure also shows the location in the context of the local road infrastructure. The N22 national road can be seen immediately to the south whilst the Maglin Road bounds the site to the west and Heathfield Estate can be seen to the north east. The development will be accessed through the Heathfield Estate from the Kilmuney Road.

These are busy urban routes, with the N22 a busy national primary route linking the site to Killarney in the West, to the N40 South Ring Road which can provide a link to Cork City via the Kinsale Road Roundabout and further onto the Dunkettle Interchange. Locally the road network links the site to the Town Centre and Ballinora.

This is to include dedicated sustainable transport, cycling and pedestrian facilities along the new Eastern Link Road (BG-U-05) which, upon completion, will run from the Kilumney Road, through Heathfield Estate and this proposed development, before intersecting with the Maglin Road. This section of the Eastern Link Road will be provided as part of Phase 1 of the proposed development. It is envisaged that the Eastern Link Road will ultimately continue past the Maglin Road and connect with local road infrastructure further to the west at Greenfields. This route can be seen in **Figure 2.2** above.

It has also been agreed with the Local Authority that an alternative route replacing the Maglin Road (BG-U-07) will be provided as part of this development. This Northern Link Road will be provided as part of Phase 2 of the development. This route can be seen in **Figure 2.2** and on completion would facilitate the closure of the Maglin Road northwards from the developed Eastern Link Road (BG-U-05) making it for 'Local Access' only. The lands immediately to the north of the site are currently being developed as a separate LRD with the submitted layout facilitating internal links for vehicular, pedestrian and cycle between the schemes. Vehicular access to the site for Phase 1 would be from the Kilumney Road through the Heathfield Estate and also from the existing Maglin Road by means of a newly formed junction. This junction on Maglin Road would allow vehicles to travel north along Maglin Road

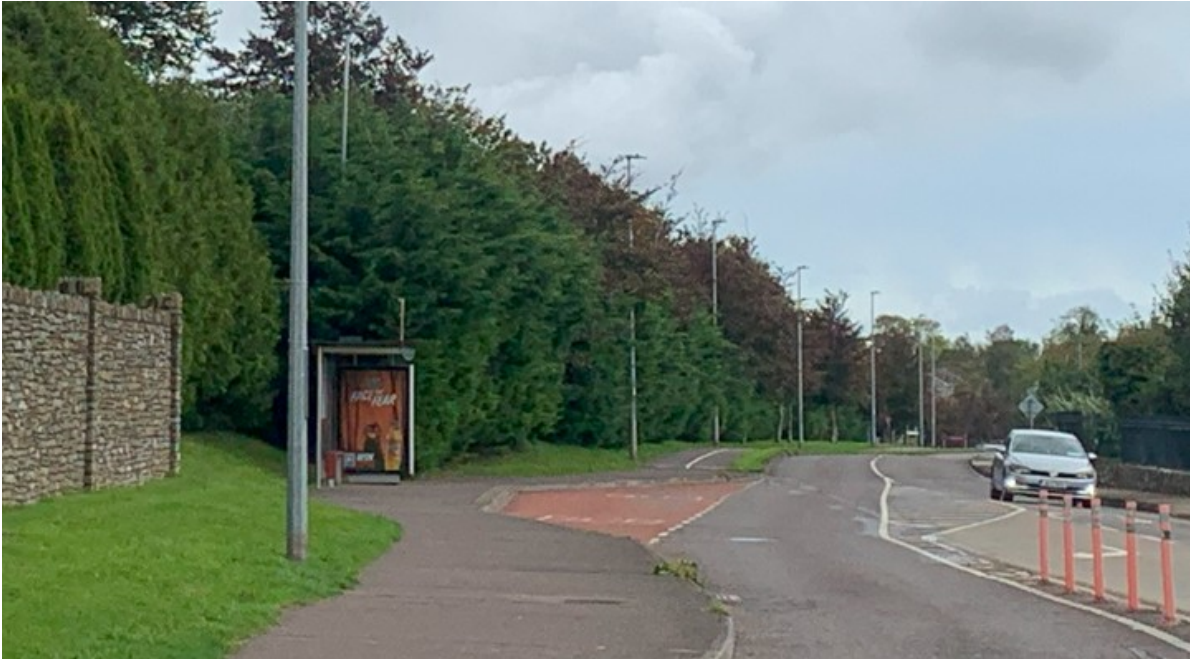
On the afternoon of the site visit pedestrian numbers along this route were low, and there were no observed cyclists in the area. The intended residential development in the area is likely to significantly increase pedestrian and cycle numbers locally. There is one bus stop on the Carriganarra Road (Route No. 233:Macroom to Cork City service) approximately 1.6km from the proposed development. Additional bus stops with more frequent public transport facilities are available on Main St.

**Figure 3.3 Bus Stop Northeast of proposed site at Carriganarra Road**

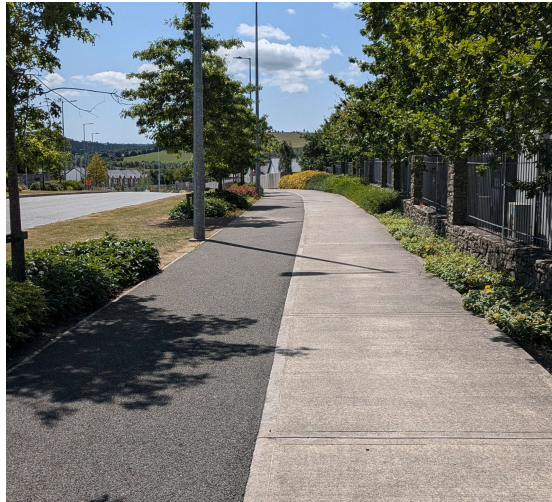
**Figure 5.1 Heathfield Footpath and Cycle Path**

**Issue:** There are currently no signs or lining associated with the off road cycle path which runs adjacent to the footpath within Heathfield Estate. Although parts of Heathfield Estate

are currently still at construction stage, this section of the road is open to the public and should be made safe for all users.

**Recommendation:** Provide the appropriate signs and lining for the cycle path as per the Cycle Design Manual.

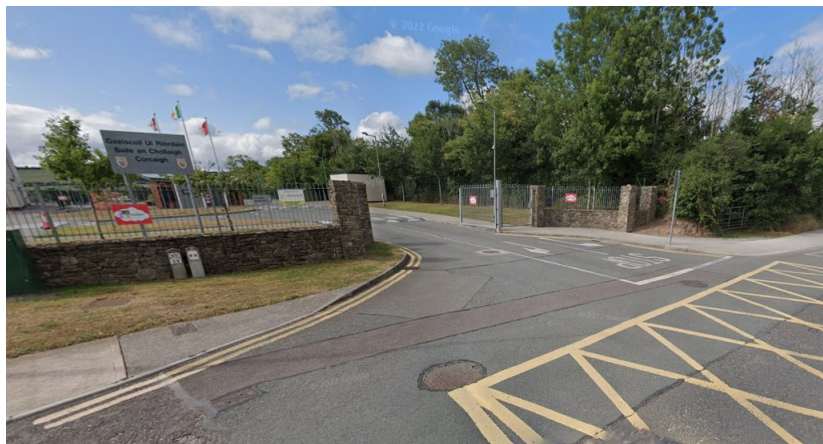
**Figure 5.2 Crossing point at Gaelscoil access junction**

**Issue:** The pedestrian crossing point at the access junction to Gaelscoil Ui Riordain is poorly defined and does not include tactile paving. The lack of tactile paving could lead to visually impaired persons crossing the junction without any warning. In addition to this, the dropped kerbs either side of the junction which define the crossing point, do not line up.

**Recommendation:** Improve the definition of the junction and pedestrian crossing point. This may require tightening up of the junction radii. Include dropped kerbs and tactile paving at both sides of the junction and ensure the crossing points line up with each other.

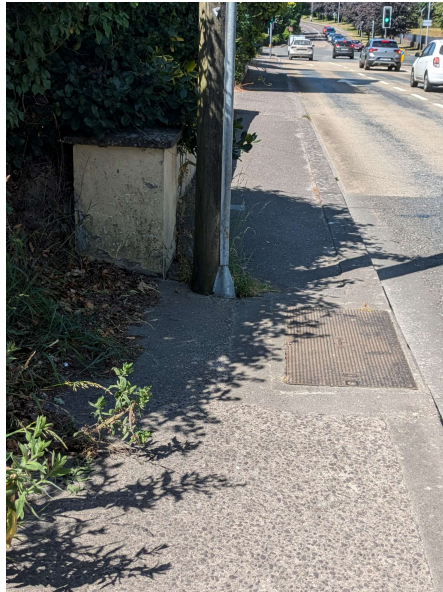
**Figure 5.3 Pinch point along footpath**

**Issue:** There is a pinch point along the footpath which runs along the southern side of the Kilmoney Road. This pinch point is located approximately 50m west of the current bus lay by and is caused by an existing telecoms pole. The footpath width here is reduced significantly

and would it would appear that a wheelchair user would not be able to pass this point without encroaching onto the roadway. Other users may also have difficulty here including pedestrians with buggies.

**Recommendation:** Relocate the telecoms pole in order to achieve the appropriate footpath width which will allow all users of the route to pass safely.

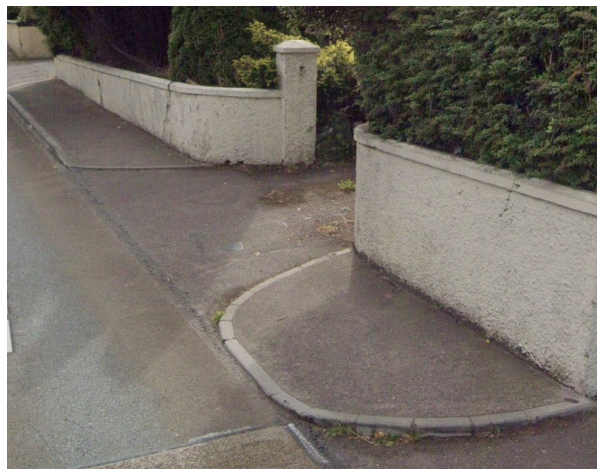
**Figure 5.4 Kerb upstands at private driveways**

**Issue:** There are a number of private driveways adjacent to each other along the southern side of the Kilumney Road as one approaches the crossroads junction with Leo Murphy Road. The footpath does not carry though these driveways and instead has kerbs defining each entrance. A number of the kerb upstands appear to be too high and could result in a trip hazard. They may also be an impediment to some users such as wheelchair users as the high kerb can make it difficult to remount the footpath.

**Recommendation:** Provide dropped kerbs of appropriate height along the route of the footpath.

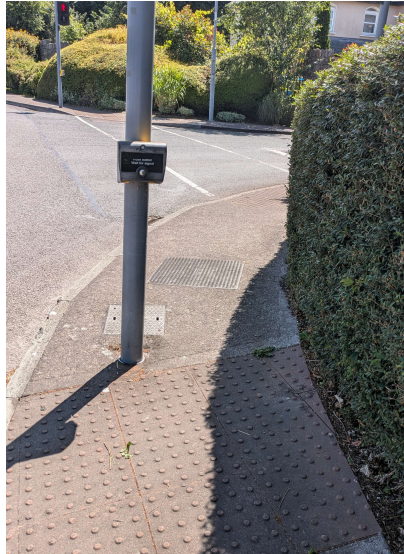
**Figure 5.5 Pinch point along footpath**

**Issue:** There is a pinch point along the footpath which runs along the southern side of the Kilumney Road. This pinch point is located at the western side of the access junction to Limeworth Housing Estate and is caused by a pedestrian traffic signal pole. The footpath width here is reduced significantly and would it would appear that a wheelchair user would not be able to pass this point without encroaching onto the roadway. Other users may also have difficulty here including pedestrians with buggies.

**Recommendation:** Widen the footpath to ensure adequate width is achieved.

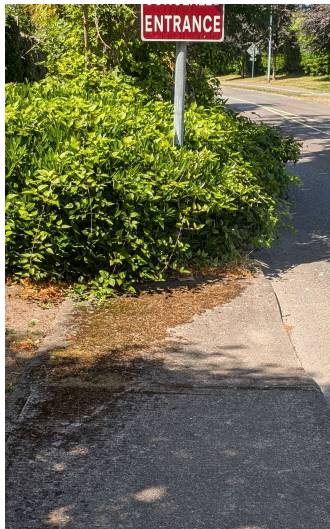
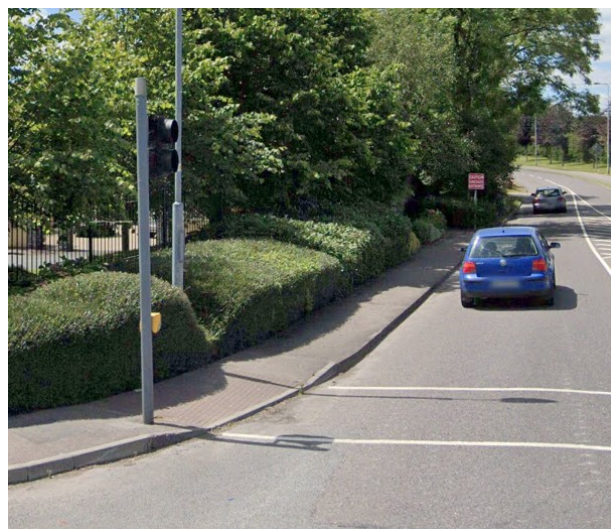
**Figure 5.6 Abrupt end to footpath**

**Issue:** The footpath which continues westbound from the Limeworth junction comes to an abrupt end and is impassible beyond this point. There is a dropped kerb at a section of the footpath which would perhaps indicate that a pedestrian crossing point was envisaged at this location, however; there is no corresponding crossing point on the opposite side of the road. Upon reaching the end of the footpath, pedestrians may encroach onto the road in order to continue travelling westbound along Kilumney Road. This could bring them into conflict with vehicles. Visually impaired persons are particularly at risk at this location.

**Recommendation:** The footpath should be blocked off by a pedestrian railing immediately past the signalised pedestrian crossing at Limeworth Estate until such time that the footpath can be extended and connected with existing infrastructure further to the west.

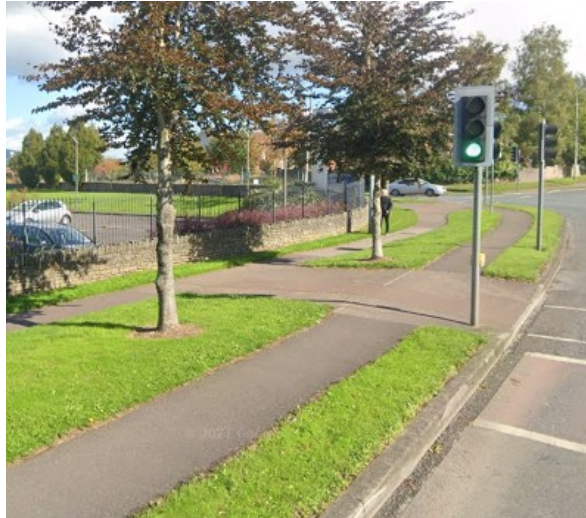
**Figure 5.7 Intersection of cycle path and crossing point**

**Issue:** At the signalised pedestrian crossing point along the northern side of Kilumney Road opposite the Limeworth Estate junction there appears to be a cycle path as well as a footpath approaching the crossing point. If this is a cycle path then the appropriate tactile paving, signage and lining should be included at its intersection with the pedestrian crossing point. Failure to provide adequate warning could result in collisions between cyclists and pedestrians at this intersection point.

**Recommendation:** Include corduroy paving at both approaches of the cycle path with the crossing point. Provide the appropriate signs and lining for the cycle path as per the Cycle Design Manual.

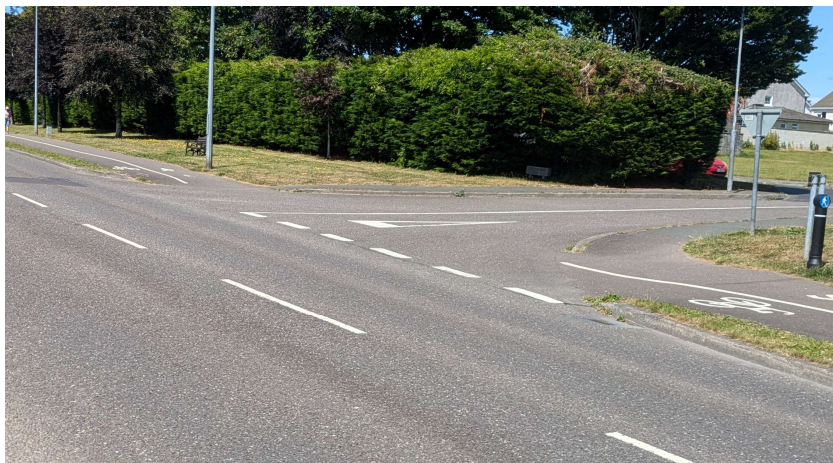
**Figure 5.8 Lack of tactile paving at crossing point**

**Issue:** No tactile paving at access junction of Cranford Pines Housing Estate. Failure to provide tactile paving can lead to vulnerable users, particularly the visually impaired, encroaching onto the roadway unbeknownst to them. This could lead to collisions between vehicles and pedestrians.

**Recommendation:** Include tactile paving at both sides of crossing point.

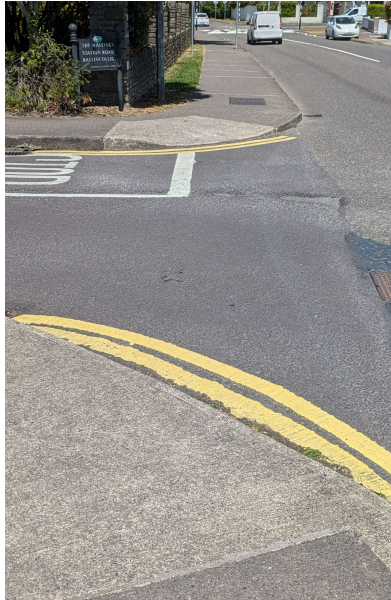
**Figure 7.1 Maltings Access Junction**

**Issue:** The access junction of The Maltings Housing Estate does not include pedestrian suitable crossing facilities. A lack of appropriate crossing facilities can lead to vulnerable pedestrians coming into conflict with vehicles.

**Recommendation:** Provide a suitable crossing point including tactile paving and dropped kerbs.

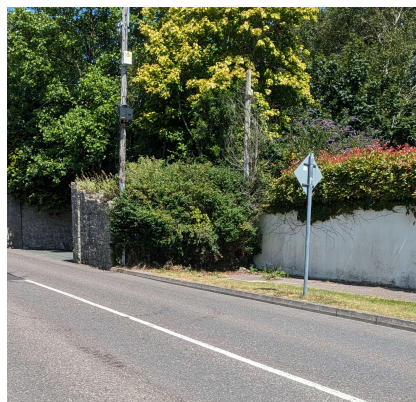
**Figure 7.2 Abrupt end to footpath**

**Issue:** The footpath along the east side of Station Road comes to an abrupt end to the north of the access junction to Beach Park and is impassible beyond this point. Upon reaching the end of the footpath, pedestrians may encroach onto the road in order to continue travelling northbound along Station Road. This could bring them into conflict with vehicles. Visually impaired persons are particularly at risk at this location.

**Recommendation:** The footpath should be blocked off by a pedestrian railing at the junction of Beach Park Estate until such time that the footpath can be extended and connected with existing infrastructure further to the north.

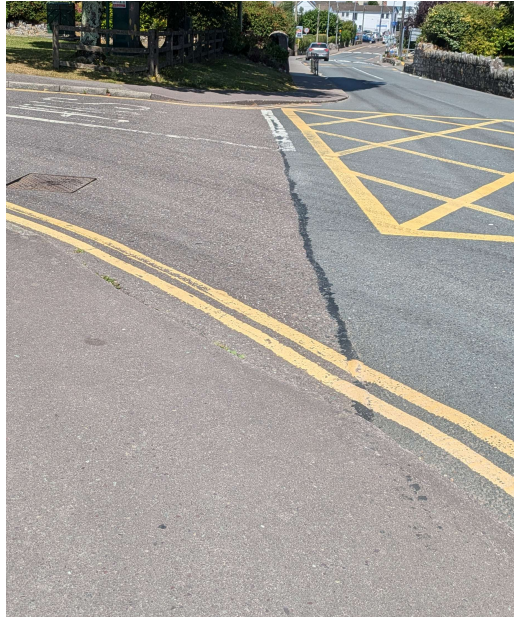
**Figure 7.3 Church View Access Junction**

**Issue:** The access junction of Church View Housing Estate does not include pedestrian suitable crossing facilities. A lack of appropriate crossing facilities can lead to vulnerable pedestrians coming into conflict with vehicles.

**Recommendation:** Provide a suitable crossing point including tactile paving and dropped kerbs.
