# MAGLIN LRD

VOLUME III  
Appendices

## VOLUME III | Contents

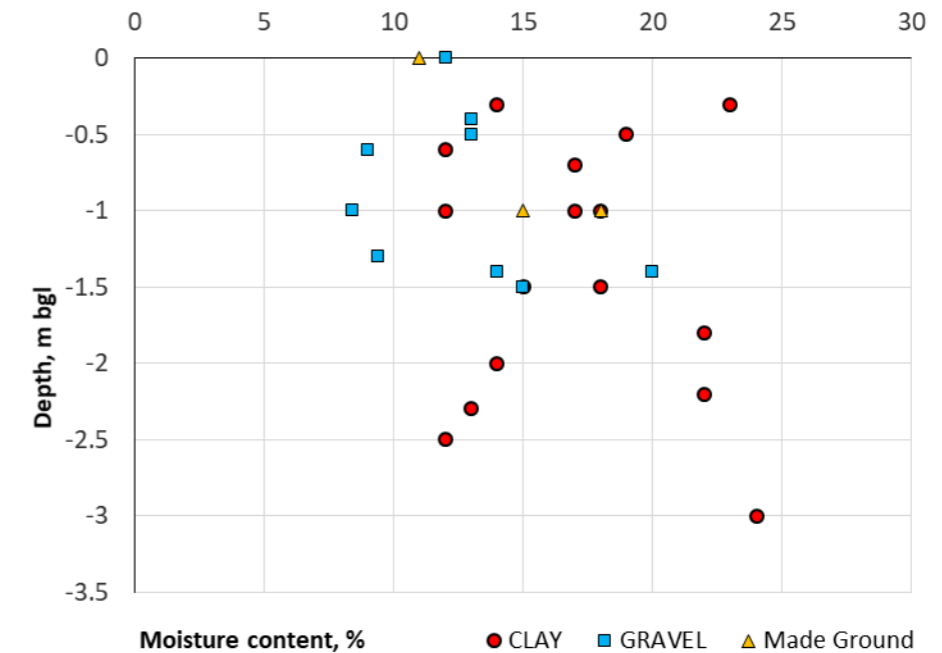
Moisture content profile

A review of the moisture content,  $w$  data indicated natural moisture content,  $w$  to plastic limit, PL ratio;  $w/PL$  ranged from 0.67 to 1.22. This was indicative of soft ( $w/PL > 1.2$ ) to stiff deposits (C504 Engineering in glacial tills, figure 5.19). The deposits were typically firm ( $w/PL 1.0 - 1.2$ ) to stiff ( $w/PL < 1.0$ ) with undrained shear strength of the order 40kPa to 150kPa are expected. Based on moisture content data the Made ground was described as firm,  $w/P < 1.0 - 1.2$ .

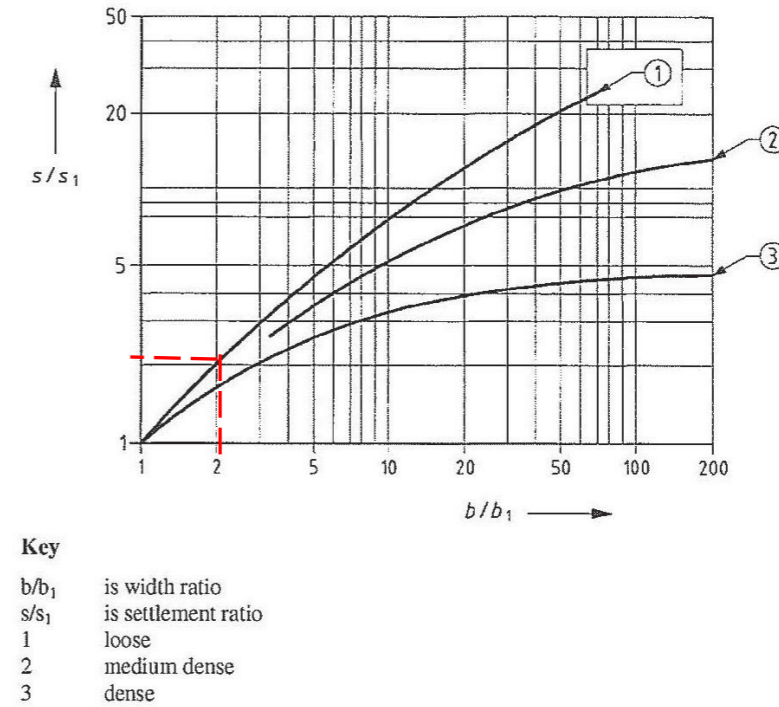
Figure K.3 — Graph for calculations of settlement based on plate loading tests

foundation; <3.0m bgl (Burland and Burbidge, 1985). For the purpose of the settlement analysis the ground was be considered homogenous within this depth. In accordance with Figure K.3, this yielded s<sub>strip</sub> /s<sub>600</sub> (s/s<sub>1</sub>) settlement ratio 2.0.

Plate (450mm dia.) settlements of 1.5mm to 5.5mm were induced under the imposed loading 100kPa at the locations and depths tested. The foundation shape, has been considered, assessing the L/B ratio, yielding a shape adjustment factor of 1.5. A further adjustment for long term settlement of 1.5 has been applied.

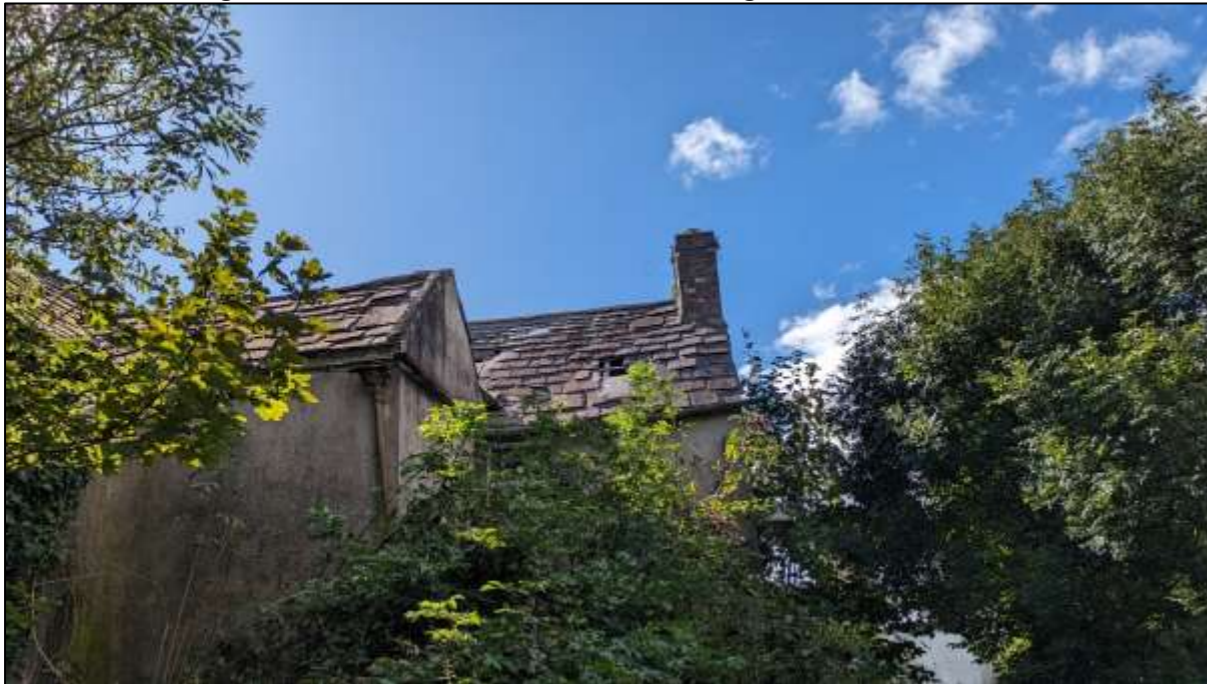
**Plate 3-1: Building onsite with features suitable for roosting bats**

However, there was no visual evidence that bats were using these potential access points, such as droppings on the building walls or urine splashes / fur-oil staining.

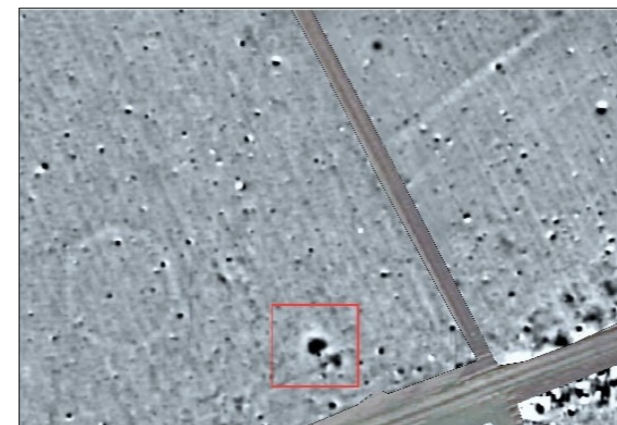
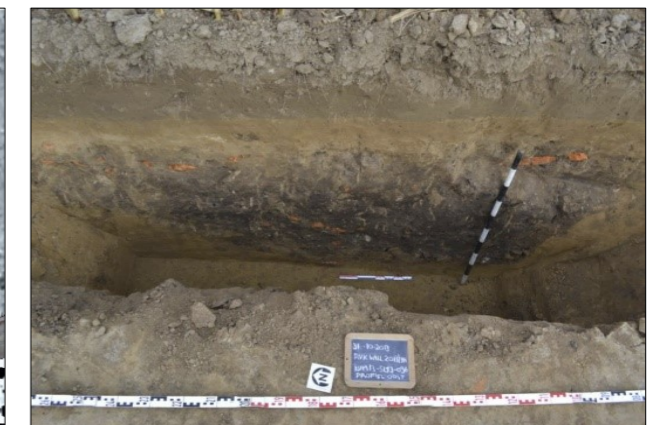
1. Magnetometer survey data in greyscale format highlighting pit remains SE of an enclosure and Roman villa. 2. Burnt-fired debris uncovered during excavation of the highlighted area SE of the same enclosure and Roman villa.

The basis for use of magnetometry in archaeological prospection derives from the abundance of natural iron oxides in most soils, and our ability to measure subtle variations in the magnetic properties of these iron oxides caused by human activity. Discrete variations in soil magnetism associated with buried archaeological remains derive typically from in situ burning and organic enrichment of the soil, through activities such as cooking and heating; pottery manufacture and metal working; as well as use of fired building materials such as ceramic tiles and brick. These burnt, fired and organic rich deposits create subtle magnetic contrasts visible as discrete magnetic anomalies superimposed on the earth's geomagnetic field.

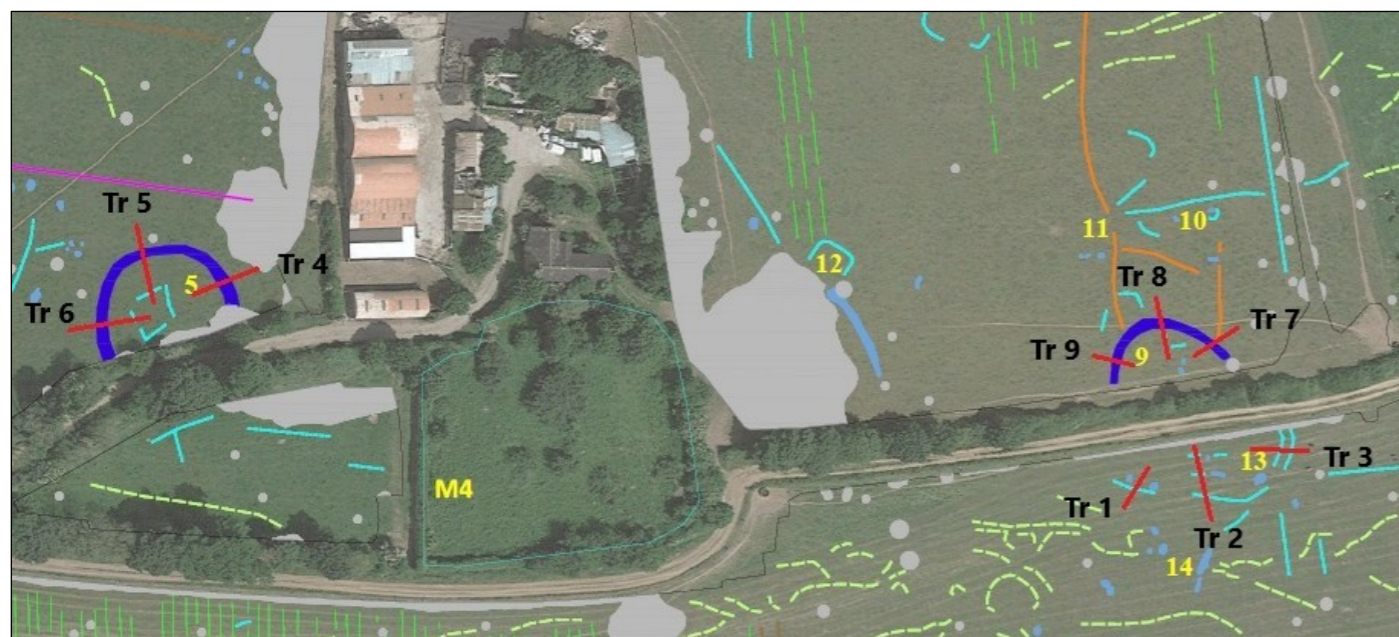
Figure 11: Trenches 1-9 excavated across Anomalies 5, 9 and 13

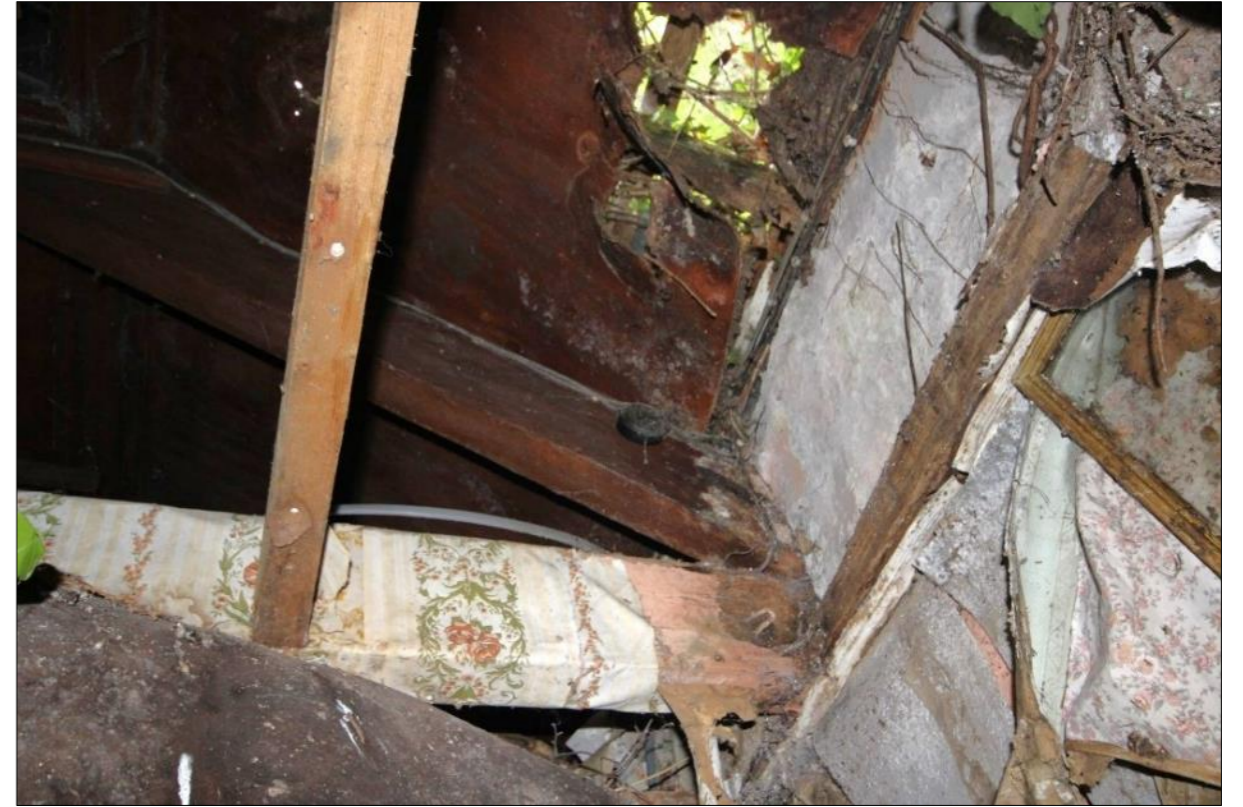
Plate 21: Damaged roof in GF01

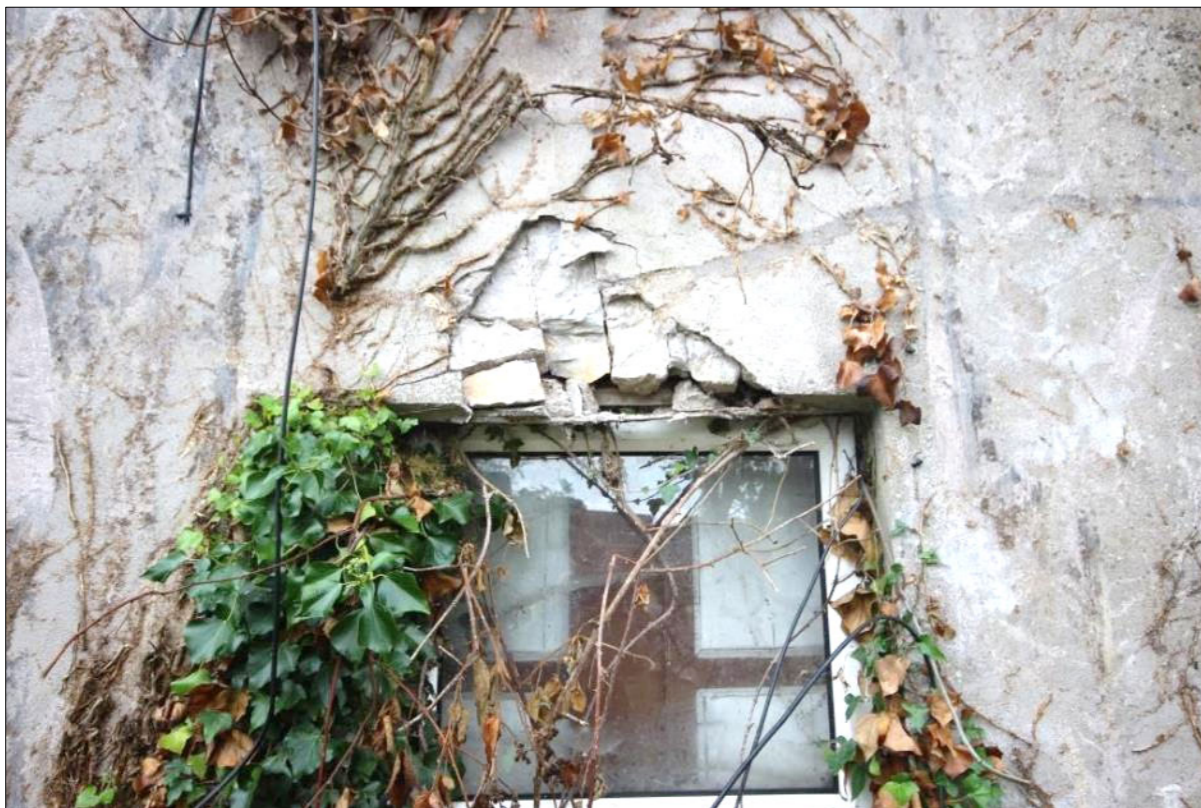
Plate 33: Deteriorating render on rear elevation

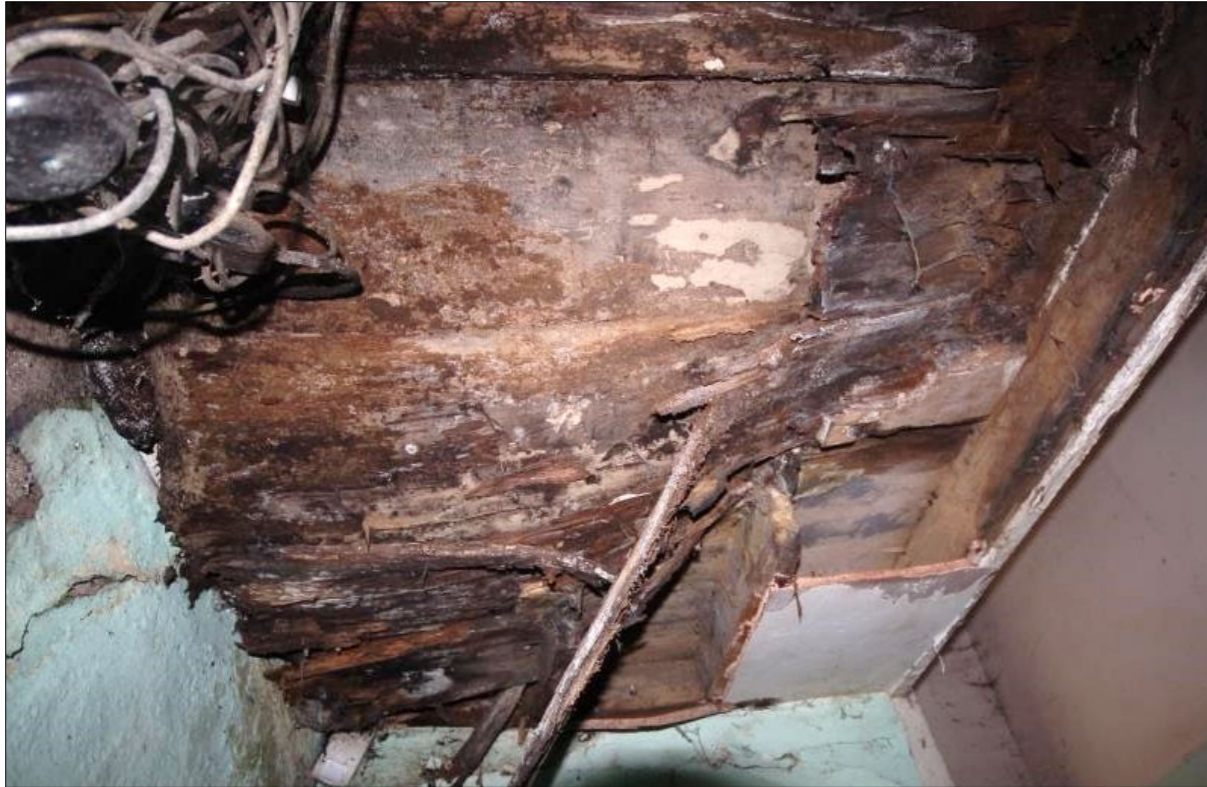
Plate 46: Decayed floor in hallway under stairs

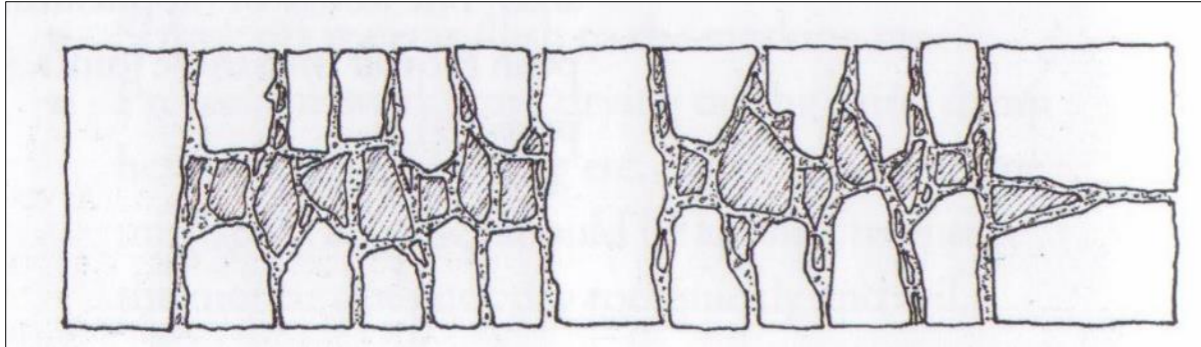
- **good tying** of face stones with the length of stones extending into the wall core rather than along the face of the wall;
- a **well-built wall core** using stones bedded horizontally, fully covered in mortar and interlocking into gaps between the backs of face stones to provide good tying throughout the wall structure.

**Figure 1:** Plan view of what typical two-sided wall structure should look like with face stones extending into wall core instead of along wall face. This feature of the masonry construction should be replicated in re-built face masonry of the cutwaters. The core should be composed of mortar-bound stone laid transversely to bind the centre of the wall together. As with a dry-stone wall the same principles apply to a mortared wall – the stone should be built in a structurally-sound manner as the lime, unlike cement, cannot provide structural support. (Image after McAfee 2009)

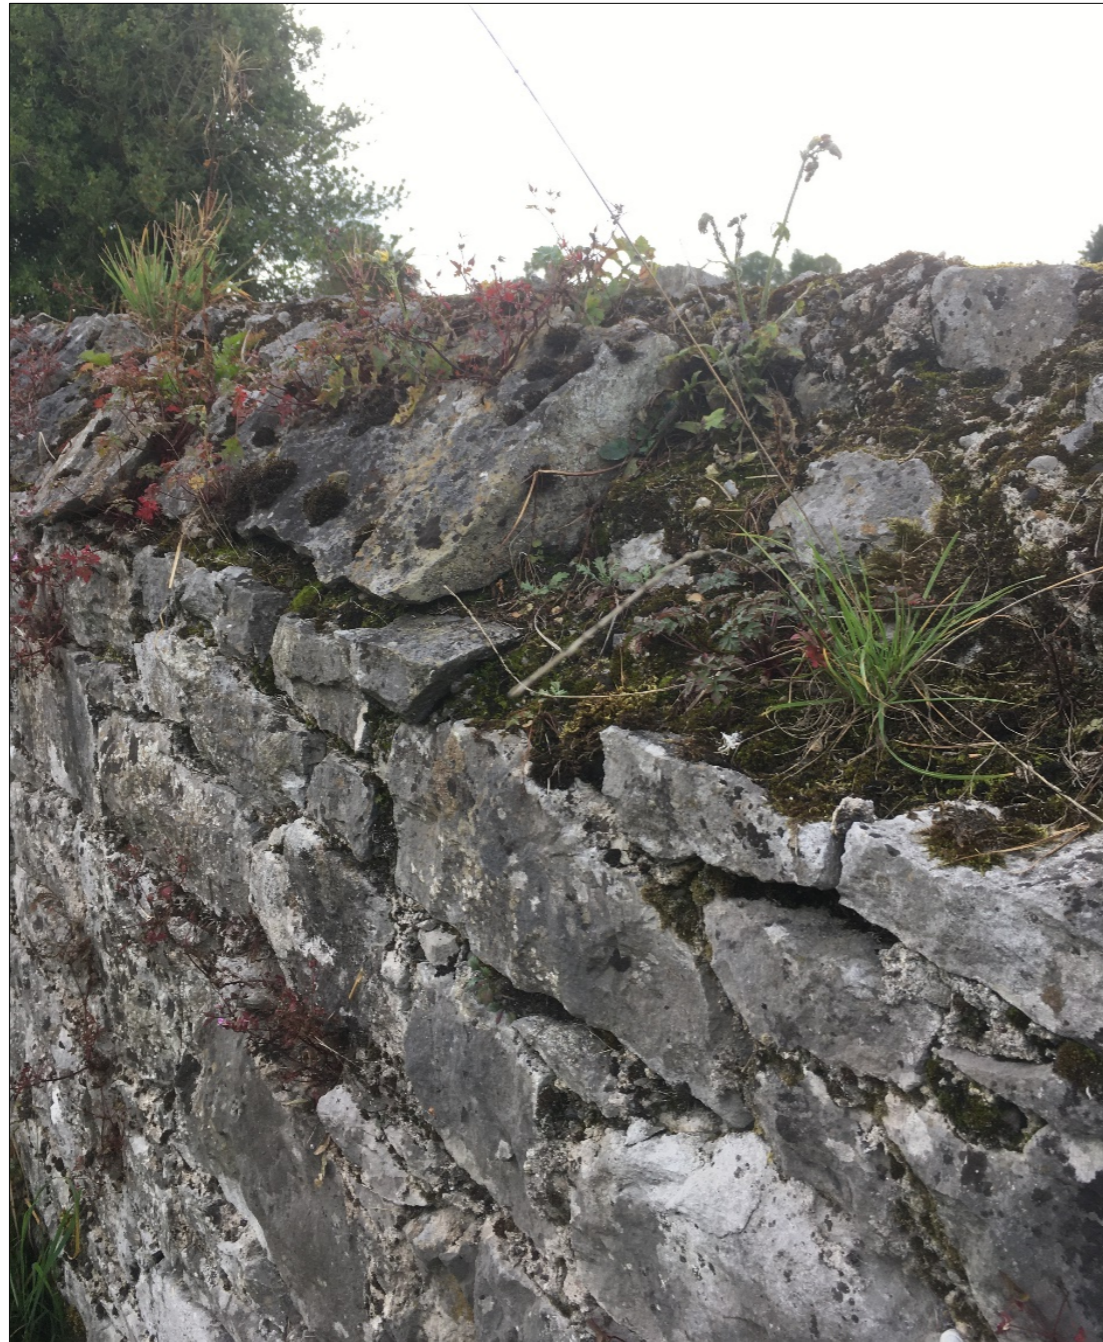
**Figure 2:** Example of constructed masonry capping to historic rubble limestone wall with sloped top surface built of triangular-shaped stones. Example shows weathered masonry, but joints should all be pointed flush with lime mortar to prevent pooling of water on wall-top. Note use of large stones to help tie wall-top faces together and retain stability.

The following examples of similar historic wall capping should be used as reference for a durable new capping with a traditional appearance:
